SITE FACT SHEET

Reservoir *Site 9*

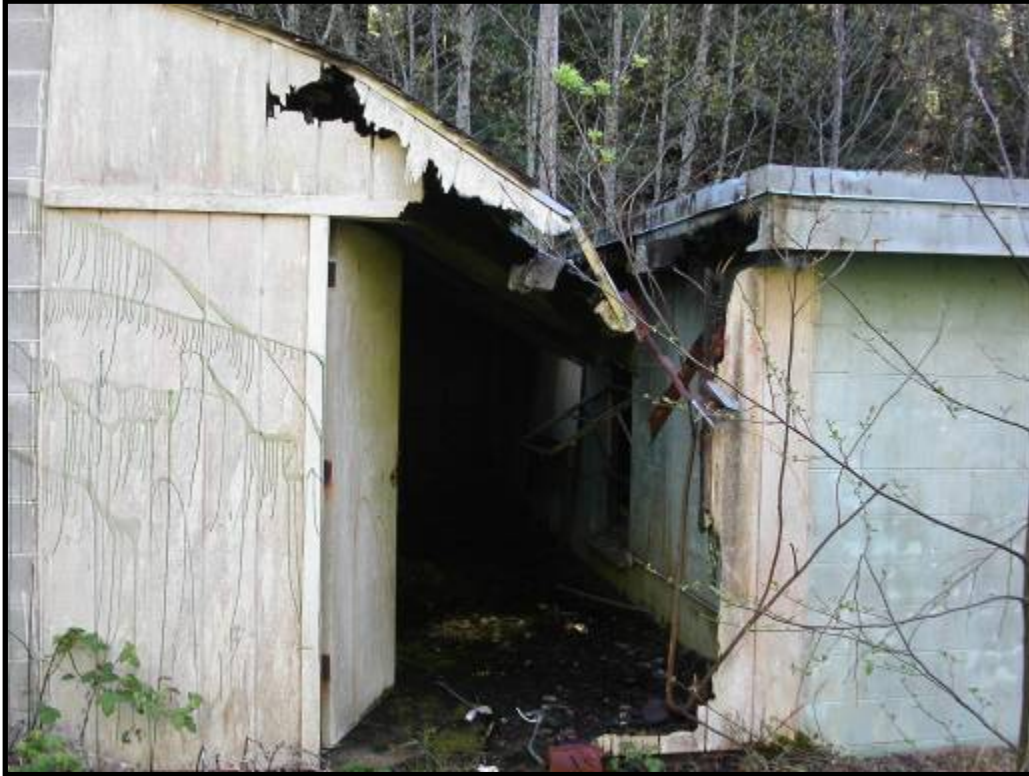
Description: This site consists of a 4-acre reservoir formed by damming Waatch Creek, an abandoned water treatment building, and a small, abandoned fish hatchery. The Reservoir was built in the 1950s to provide a source of drinking water for the Makah AFS Cantonment Area and Family Housing Area. The water treatment building also served as a pump station. The dam was removed by the Makah Fisheries Department in 2003, when a new fish-friendly culvert was also installed and fish habitat in the area was restored. Containers labeled as lime and chlorine are present in the water treatment building.

Community Impacts: The abandoned buildings and water treatment equipment present physical hazards. The abandoned containers are a potential chemical hazard.

Planned Activities: Remove abandoned structures from the site, if desired by the current property owner; remove abandoned chemical containers.
