SITE FACT SHEET

Cantonment Area *Site 11*

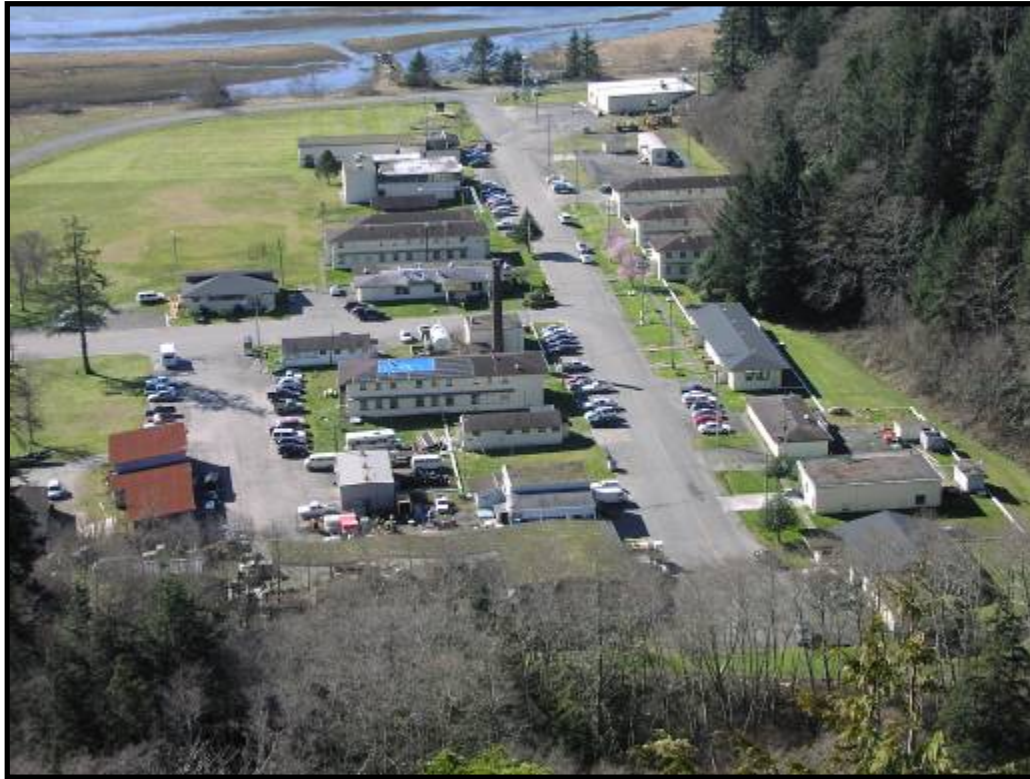
Community Impacts: Asbestos-containing material in buildings; transformers; possible petroleum-contaminated soils; possible pesticide contamination in Building 17; some buildings are in poor repair.

Planned Activities: Conduct semi-annual sampling to monitor creeks and ground water; conduct test pit investigation to locate underground storage tanks and contaminated soil and remove if present; remove hydraulic lift and contaminated soil; remove asbestos-containing materials; remove abandoned buildings.
