# SITE FACT SHEET

## Water Towers *Site 10*

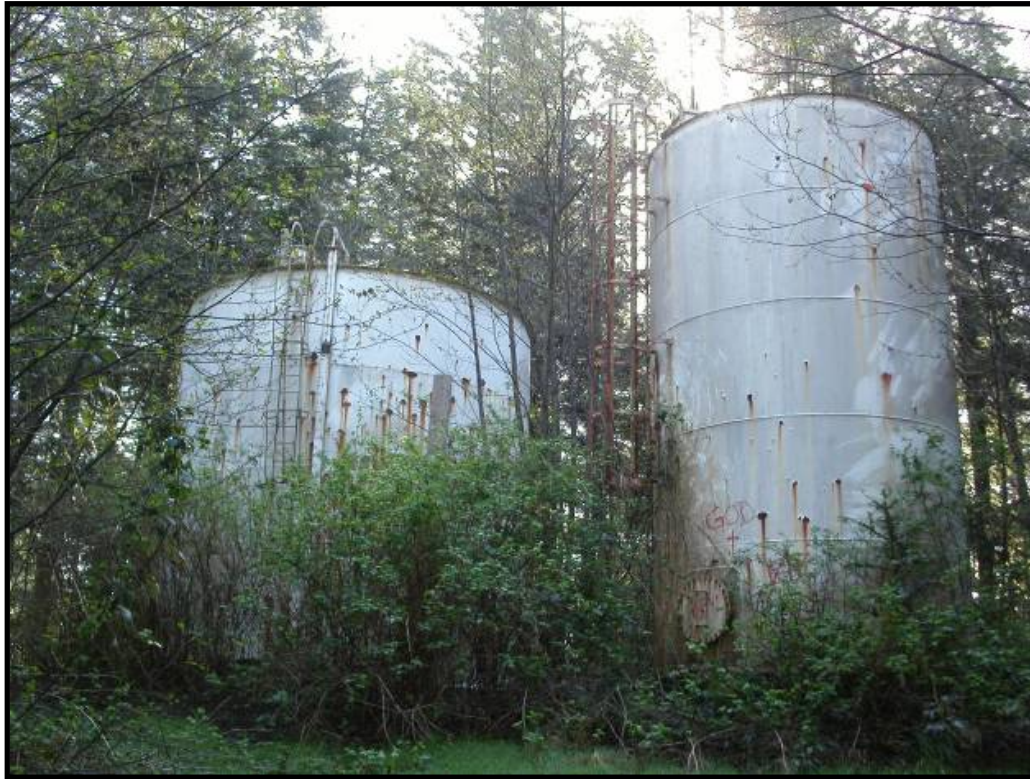
**Description:** The site consists of two abandoned steel water towers (75,000 gallons and 30,000 gallons) near the Cantonment Area and the Family Housing Area. The Water Towers were part of the water-supply system for the Makah AFS and were used to store treated water from the Reservoir. The tanks were built in the 1950s, when the AFS was constructed. Steel ladders attached to the tanks provide access to the tops.

**Community Impacts:** The towers and ladders present physical hazards; lead-based paint is present on the tanks and in soils adjacent to the tanks.

**Planned Activities:** Deconstruct and remove towers; remove lead-impacted soil near Water Towers.
